Praca pogładowa
Review paper

Katarzyna Wochna, Jarosław Berent, Anna Smeđra

When genetic tests fail – an attempt to identify victims of gas explosion caused by damage to a high-pressure gas pipeline, with reference to problems related to the retrieval of ante-mortem dental records

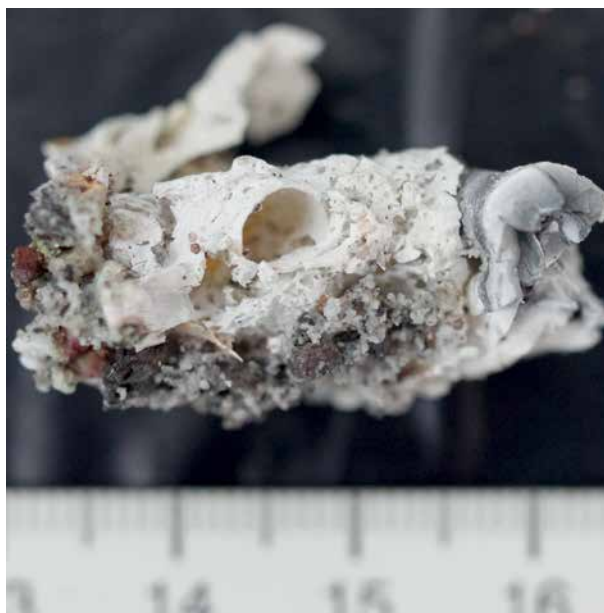
Ryc. 1. Fragment lewej szczęki z częściowo zachowanym zębem 26 lub 27 (szczątki Y)

Fig. 1. A fragment of the left maxilla with partially preserved tooth 26 or 27 (remains Y)

- 3) fragment prawdopodobnie lewej szczęki z zachowaną częścią lewej zatoki szczękowej (ryc. 1). Fragment miał ok. 31 mm długości i 18 mm szerokości. Podstawa kostna czterech ścian zatoki szczękowej została zachowana, a w kości obecne były trzy korzenie zęba 26 lub 27 z niewielkim fragmentem korony. Dystalnie zidentyfikowano pusty zębodoł 27 lub 28;
- 4) fragment prawdopodobnie lewej szczęki z fragmentem lewej kości podniebiennej (ryc. 2). Zewnętrzna powierzchnia kości była wypukła, natomiast wewnętrzna – wklęsła, co odpowiadało krzywiznie wyrostka zębodołowego okolicy kła i zębów przedtrzonowych. Korzenie zęba 23 (z wierzchołkiem zakrzywionym w lewą stronę), 24 (z dwoma korzeniami i zachowaną przegrodą międzykorzeniową) i 25 (z wierzchołkiem zakrzywionym lekko w lewą stronę) były zachowane.

- 3) A fragment of (probably) the left maxilla with a preserved part of the left maxillary sinus (Fig. 1). The fragment was about 31 mm long × 18 mm wide, and the osseous base of the four walls of the maxillary sinus was preserved. Three roots of tooth 26 or 27 with a small fragment of the dental crown were present in the bone. An empty alveolus (tooth 27 or 28) was identified distally.
- 4) A fragment of (probably) the left maxilla with a piece of the left palatine bone (Fig. 2). The outer surface of the bone was convex, while the inner surface was concave, which corresponded to the curvature of the alveolar process in the region of the canine tooth and premolar teeth. The roots in teeth 23 (with apex curved to the left), 24 (with two roots and preserved interradicular septum) and 25 (with apex curved slightly to the left) were preserved.

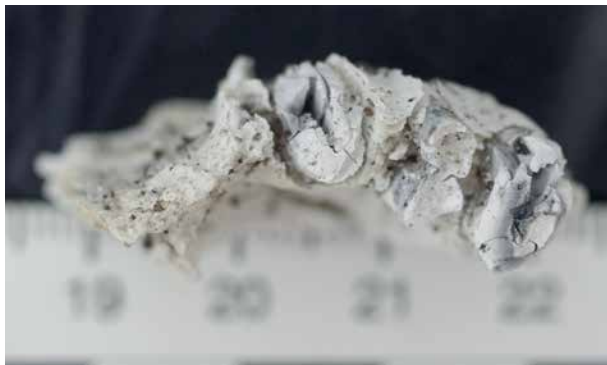
Ryc. 2. Fragment lewej szczęki z częściowo zachowanymi korzeniami zębów 23–25 (szczątki Y)
Fig. 2. Fragment of the left maxilla with partially preserved roots of teeth 23–25 (remains Y)

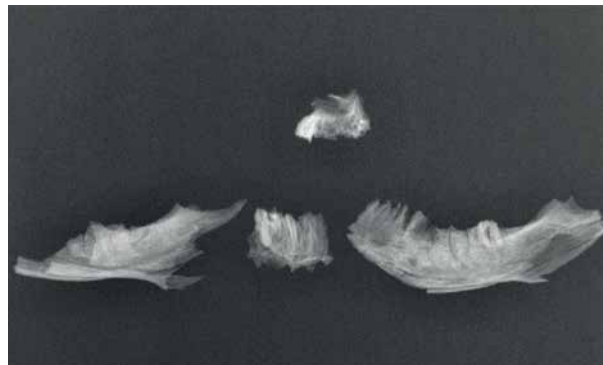
Ryc. 3. Pośmiertne RTG szczątków Y
Fig. 3. Post-mortem X-ray image of remains Y

W obu przypadkach sporządzono dokumentację radiologiczną (ryc. 3) oraz fotograficzną zachowanych zębów i wystąpiono do prokuratury z wnioskiem o przesłanie dokumentacji stomatologicznej obu mężczyzn. Udało się uzyskać karty leczenia stomatologicznego tylko jednego z nich. Trzeba podkreślić, że otrzymana historia leczenia obejmowała siedem lat, przy czym pacjent nie zgłaszał się na wizyty regularnie. Ostatnią wizytę u stomatologa odnotowano ponad pięć lat przed wypadkiem. Z dokumentacji wynikało, że zęby 18–16, 26, 36–37 i 45 zostały usunięte, zaś brak zębów 11–22 miał charakter pourazowy i odbudowano je za pomocą ruchomej protezy częściowej górnej. Karta leczenia nie zawierała

Radiological (Fig. 3) and photographic documentation of the preserved teeth was prepared in both cases, and a request was sent to the Prosecutor's Office to supply the dental records of both men. However, the dental treatment records were retrieved for only one of them. It should be stressed that the patient's documented history of dental treatment covered a period of seven years, though he did not report for appointments regularly. The final dental appointment was recorded over five years before the accident.
